WL-TR-97-2053

THIN DENSE CHROME BEARING INSERTION  
PROGRAM

GE AIRCRAFT ENGINES  
ADVANCED ENGINEERING PROGRAMS DEPT  
ONE NEUMANN WAY  
CINCINNATI OH 45215-6301

FINAL REPORT FOR 03/01/92-12/01/96

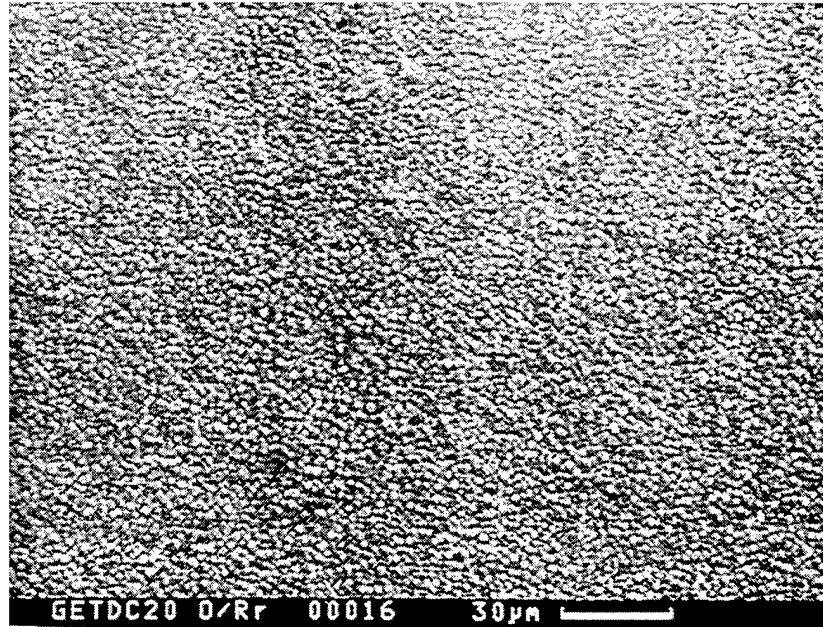
500X

**Figure 20. Thermal Shock Specimen GE TDC 20 SEM Photo of Position 1 (0°) in Raceway (MRC Round 1). *TDC is in good condition.***

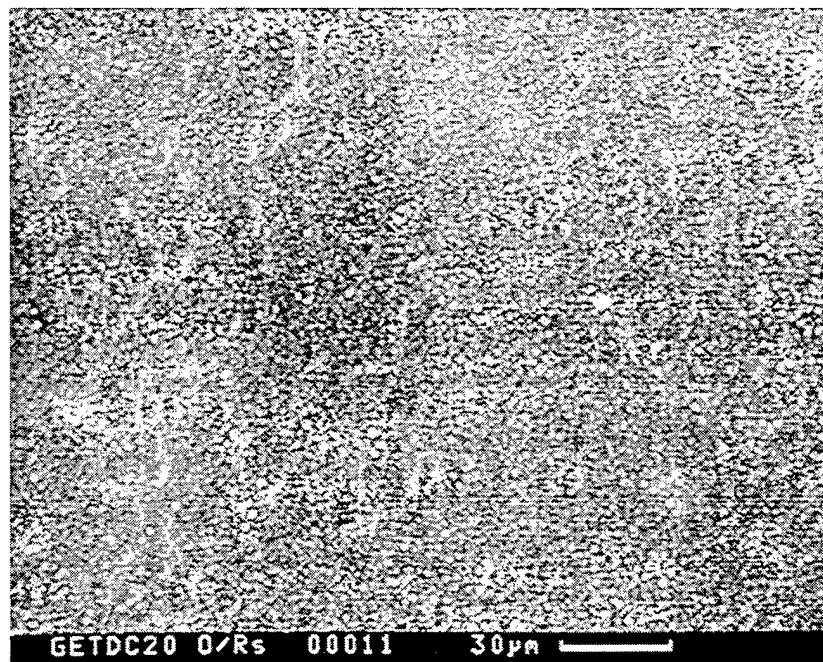
500X

**Figure 21. Thermal Shock Specimen GE TDC 20 SEM Photo of Position 1 (0°) in Shoulder (MRC Round 1). *TDC is in good condition.***

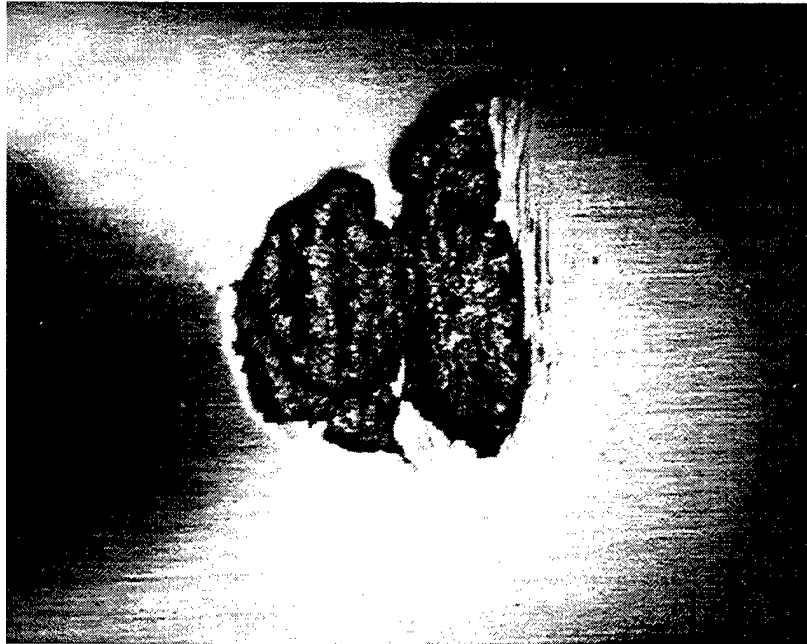
10X

**Figure 41. SEM Photo of GE TDC 32 Inner Ring Spall from MRC Round 1.**  
*Baseline plain bearing, 250 hours, only plain bearing failure.*

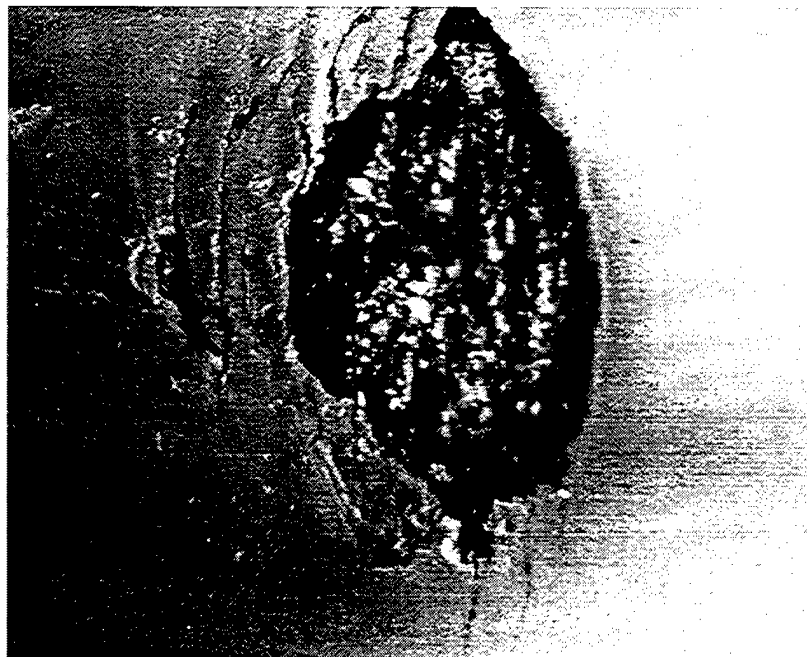
30X

**Figure 42. SEM Photo of GE TDC 24 Inner Ring Spall from MRC Round 1.**  
*TDC plated bearing, 876 hours, one of three plated bearing failures.*

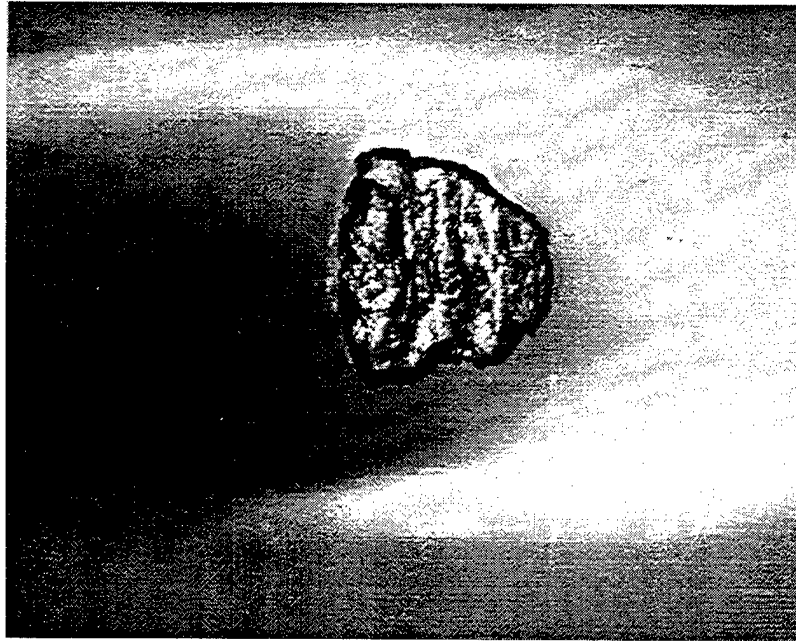
10X

**Figure 43. SEM Photo of GE TDC 09 Inner Ring Spall from MRC Round 1.**  
*TDC plated bearing, 2152 hours, one of three plated bearing failures.*

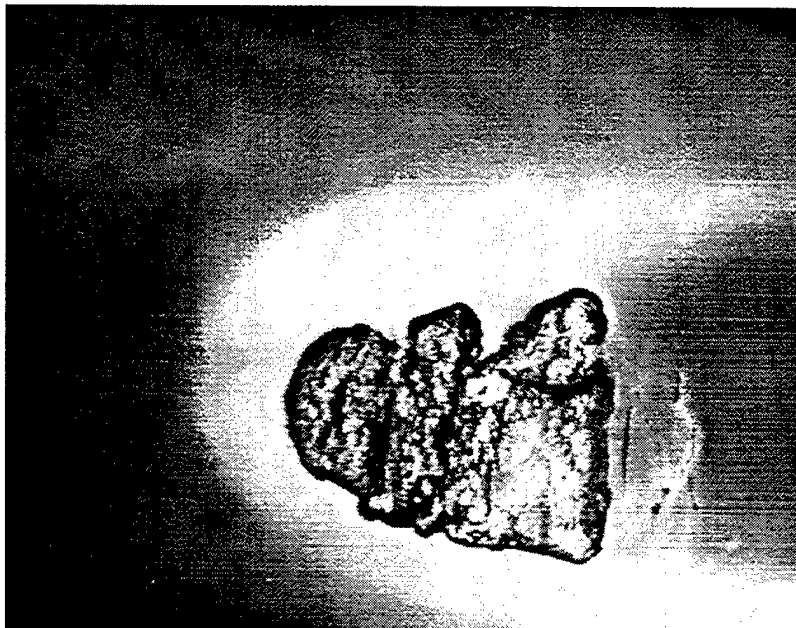
10X

**Figure 44. SEM Photo of GE TDC 45 Inner Ring Spall from MRC Round 1.**  
*TDC plated bearing, 802 hours, one of three plated bearing failures.*

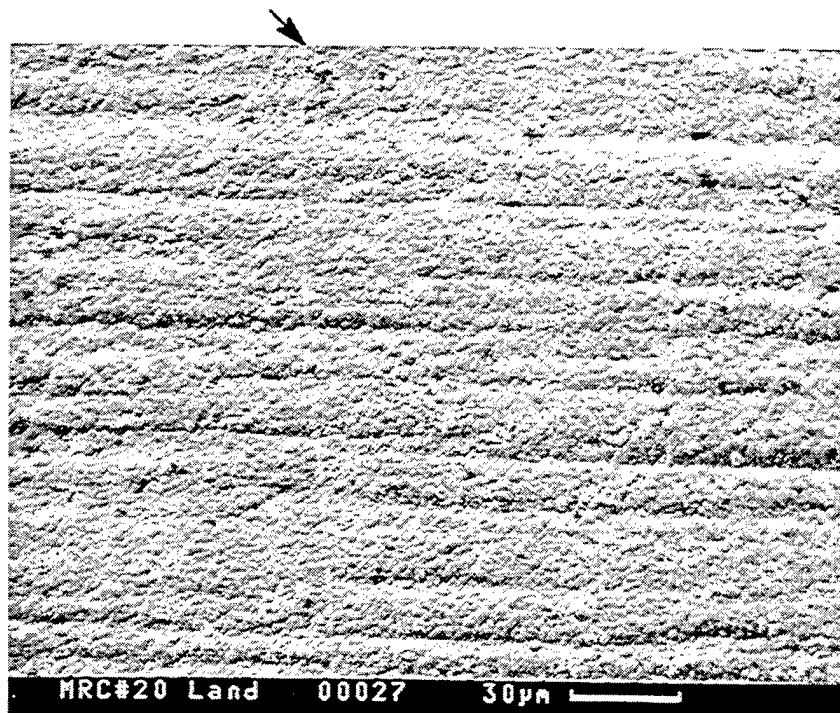
500X

**Figure 50. SEM Photo of Bearing Land, SEI Mode.**  
*Note crack in TDC coating.*

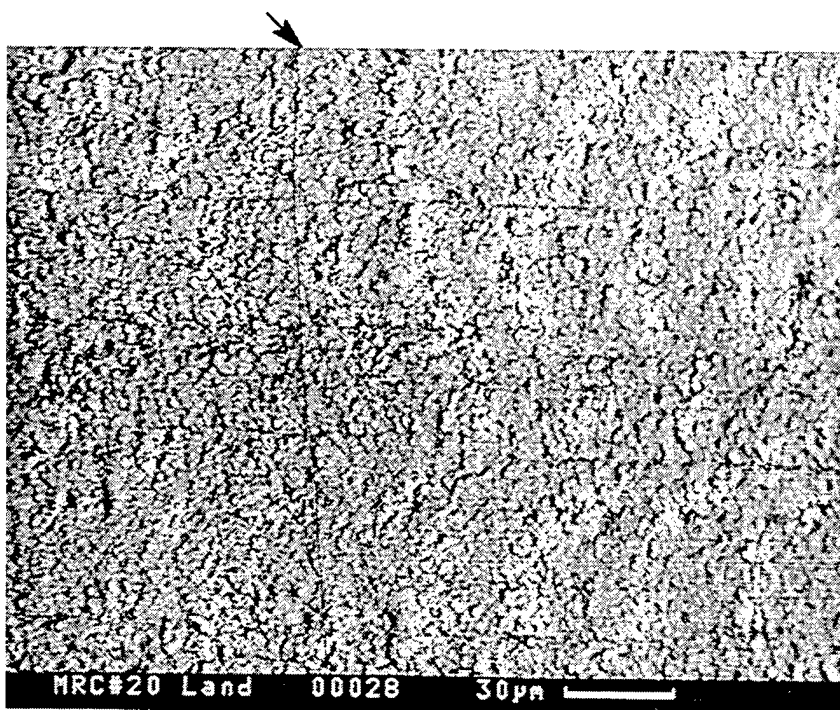
500X

**Figure 51. SEM Photo of Bearing Land, BEI Mode.**  
*Note crack in TDC coating.*

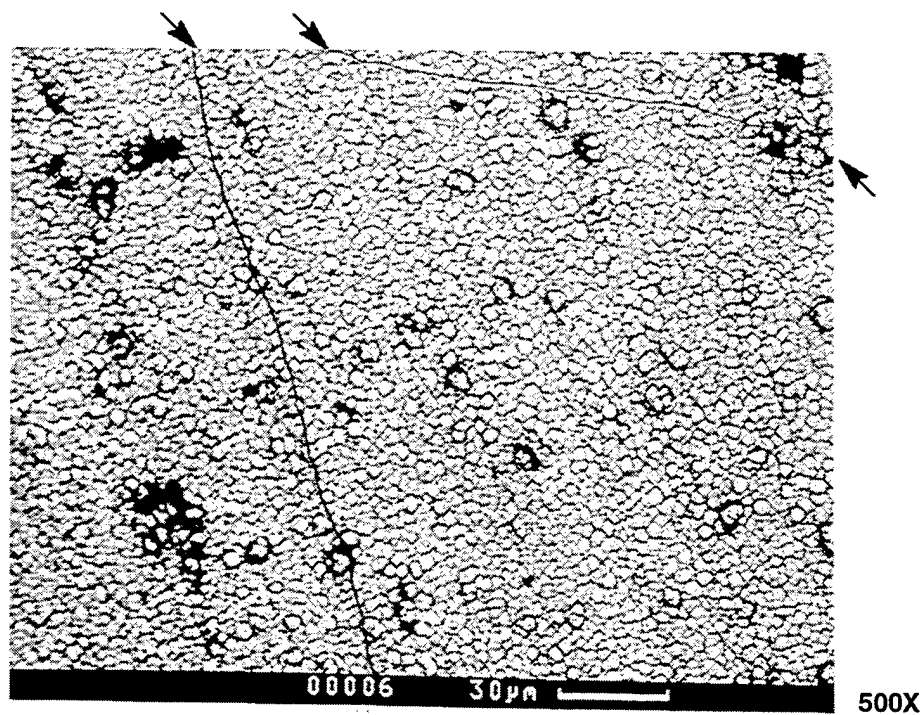
**Figure 54. SEM Photo of Edge of Bearing Raceway Track, BEI Mode.**  
*Note cracks.*

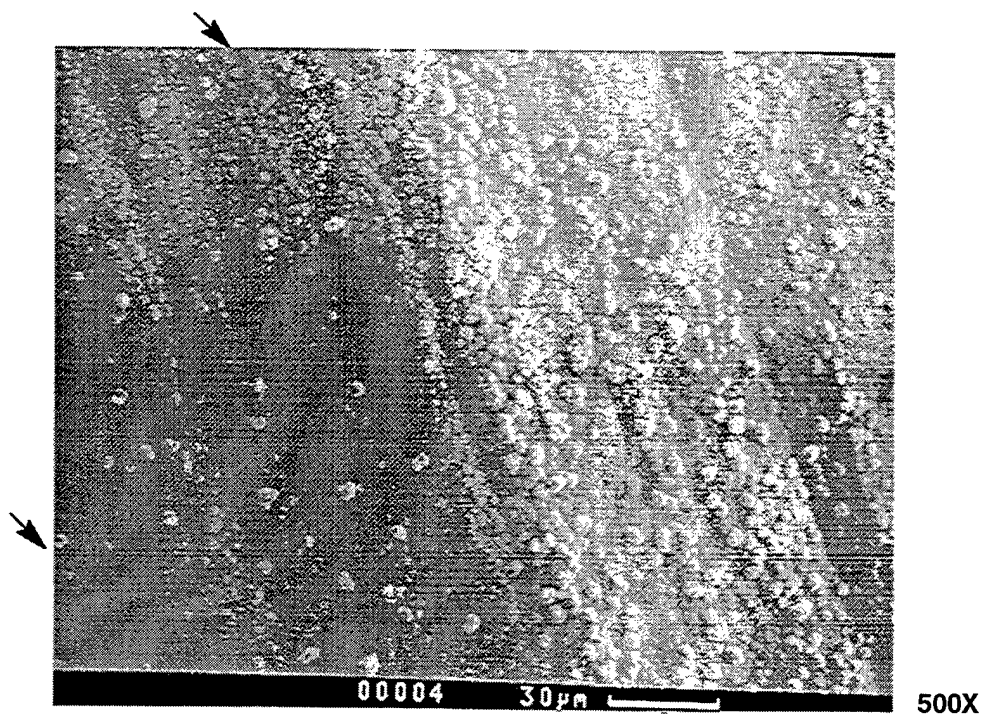
**Figure 55. SEM Photo of Edge of Land No. 1, SEI Mode.**  
*Note chrome clusters and cracks.*

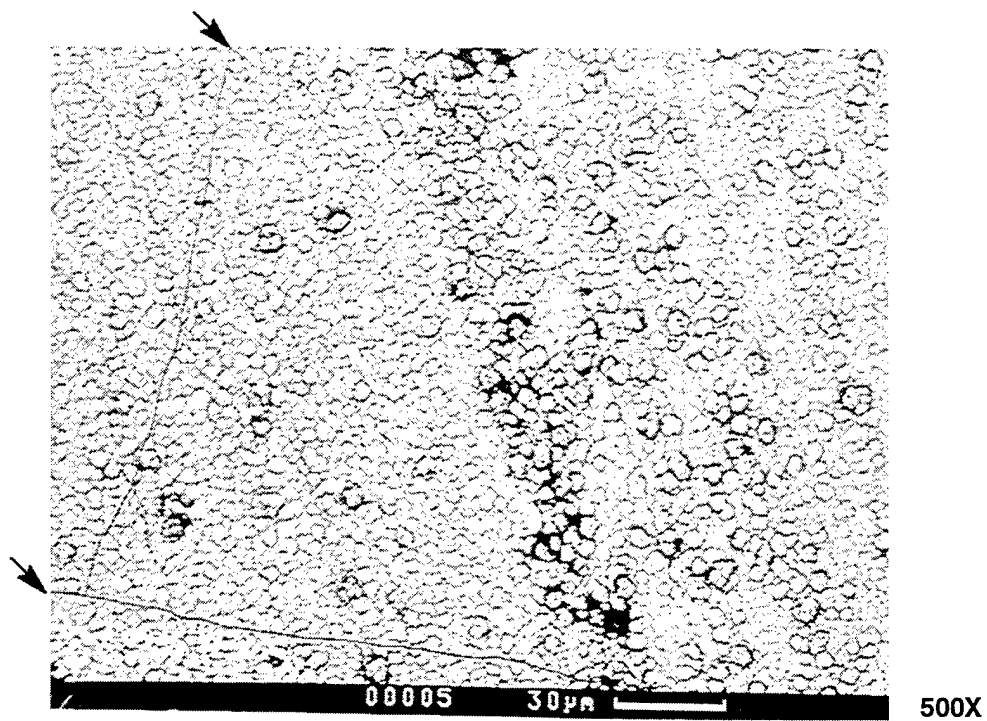
**Figure 56. SEM Photo of Edge of Land No. 1, BEI Mode.**  
*Note crack in same area as Figure 55 highlighted in BEI mode.*

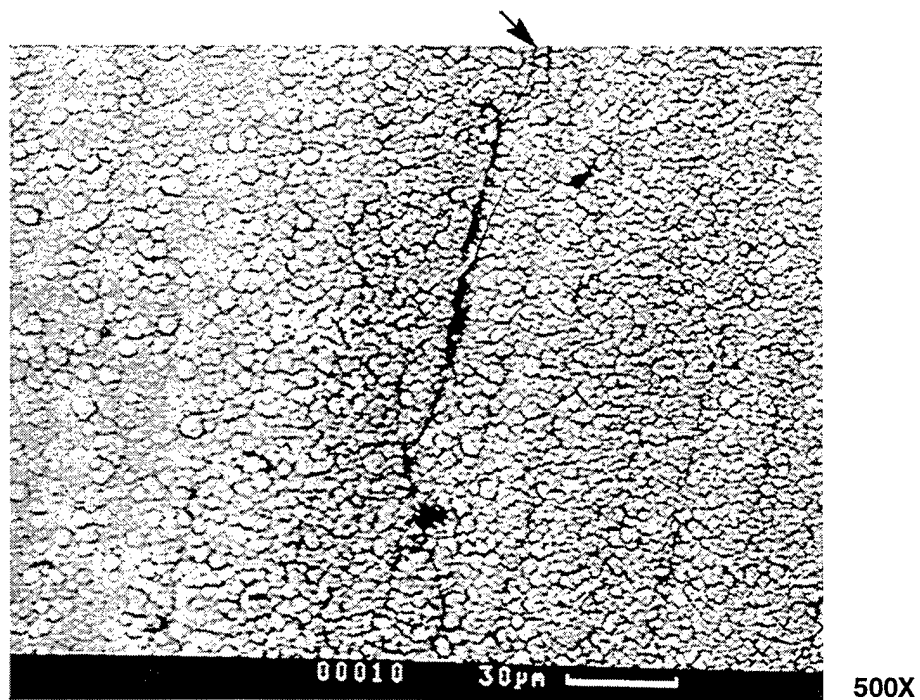
**Figure 57. SEM Photo of Edge of Land No. 2, BEI Mode.**  
*Note crack.*

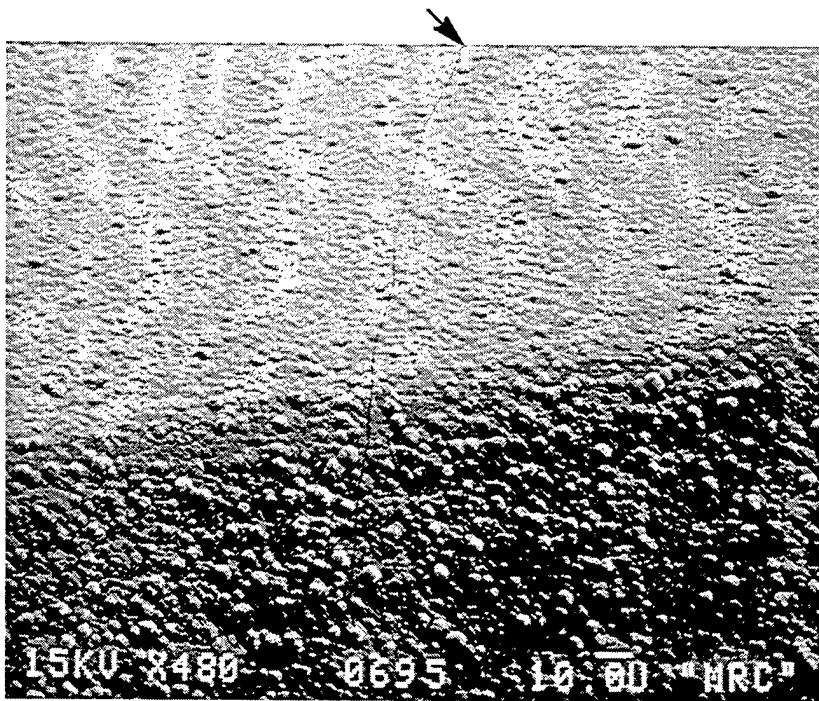
500X

**Figure 66.** SEM Photo of Raceway, 90°. *Note crack.*

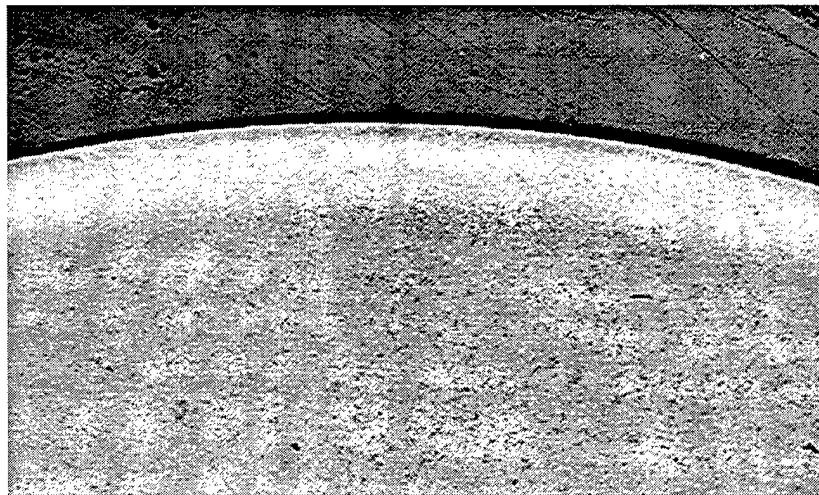
25X

**Figure 71. Subsurface Stress Induced Microstructural Alteration (White Layer) in Ball from Round 2/Test 1.** *The layer covered the entire ball indicating the ball was spinning.*

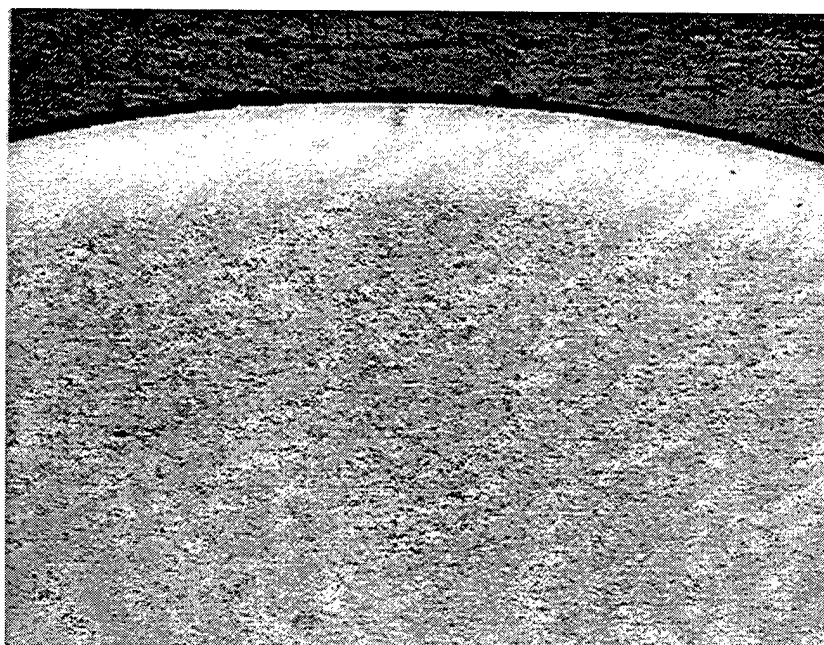
25X

**Figure 72. Subsurface Stress Induced Microstructural Alteration (White Layer) in Ball from Round 2/Test 4.** *The layer covered the entire ball indicating the ball was spinning.*

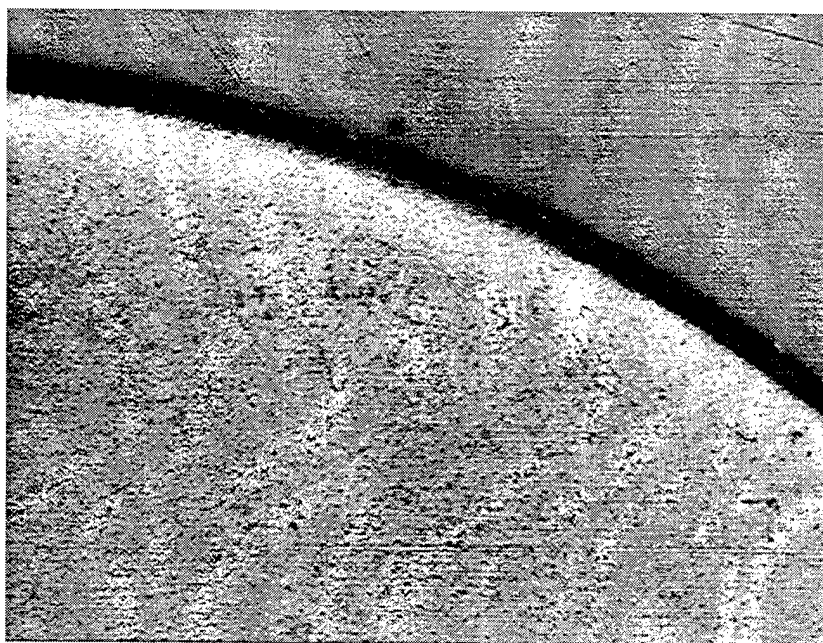
25X

**Figure 73. Subsurface Stress Induced Microstructural Alteration (White Layer) in Ball from Round 2/Test 6.** *The layer was in a circumferential line indicating the ball was tracking.*

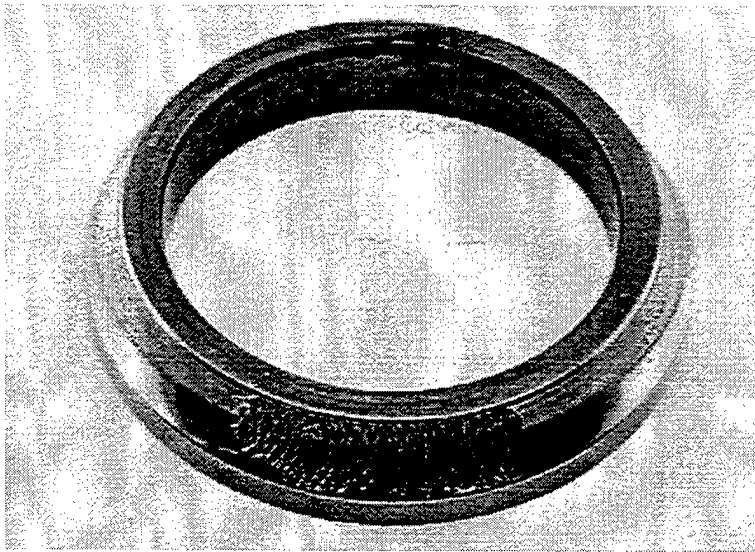
**Figure 90. Photo of Plain Bearing Spall Which Failed at 4,030 Hours.**

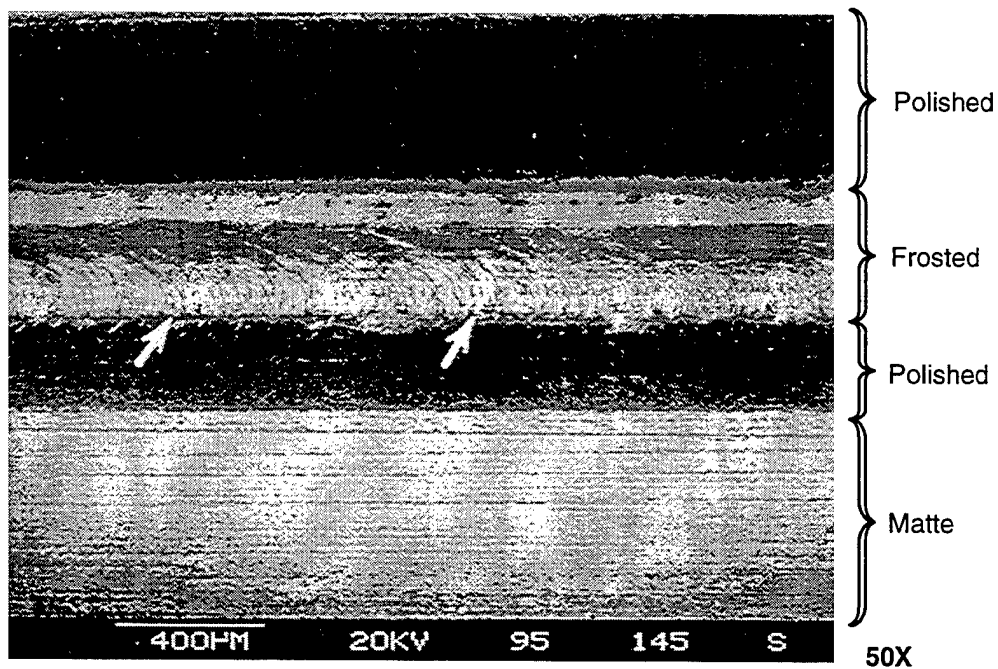
**Figure 113. Photomicrograph of Frosted Band in Bearing S/N 0022.**  
*Note distressed TDC from sliding ball in ball track (arrows).*

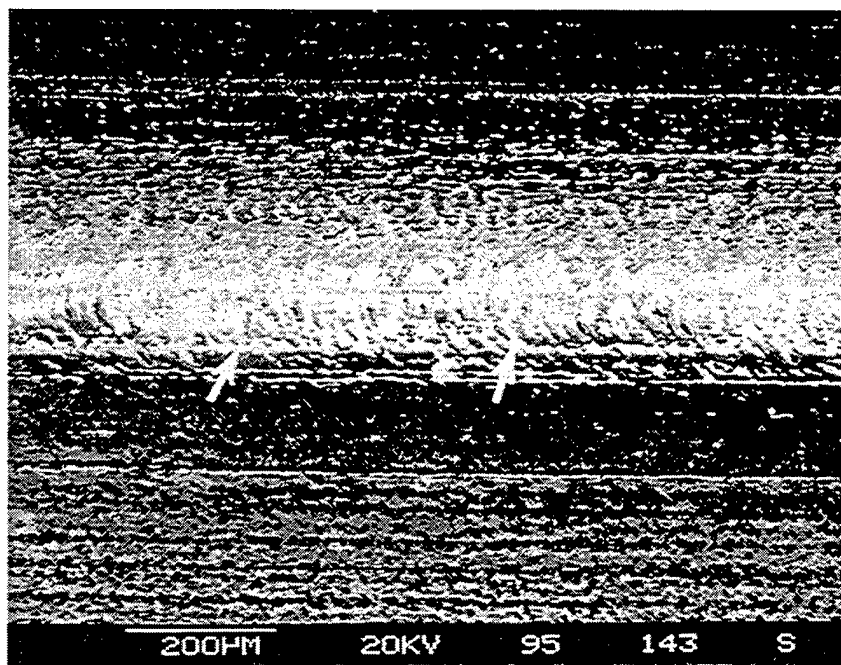
100X

**Figure 114. Photomicrograph of Frosted Band in Bearing S/N 0025.**  
*Note sliding type damage in ball track (arrows).*

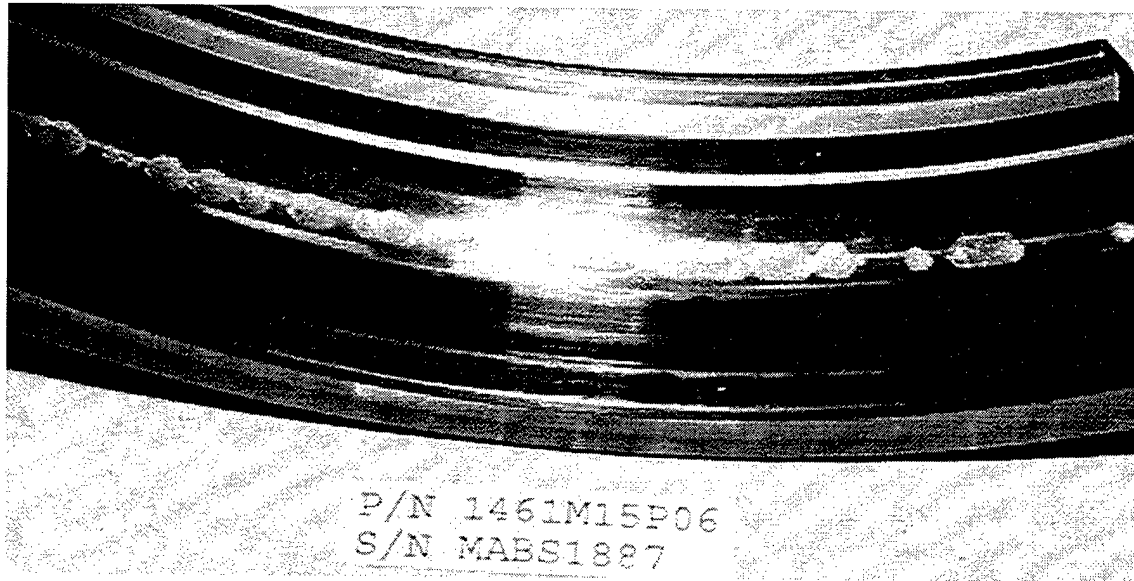
**Figure 117. Photo of Outer Race Spalling on Bare, Contamination Tested Bearing.**  
*Bare bearings have significantly less resistance to contamination.*

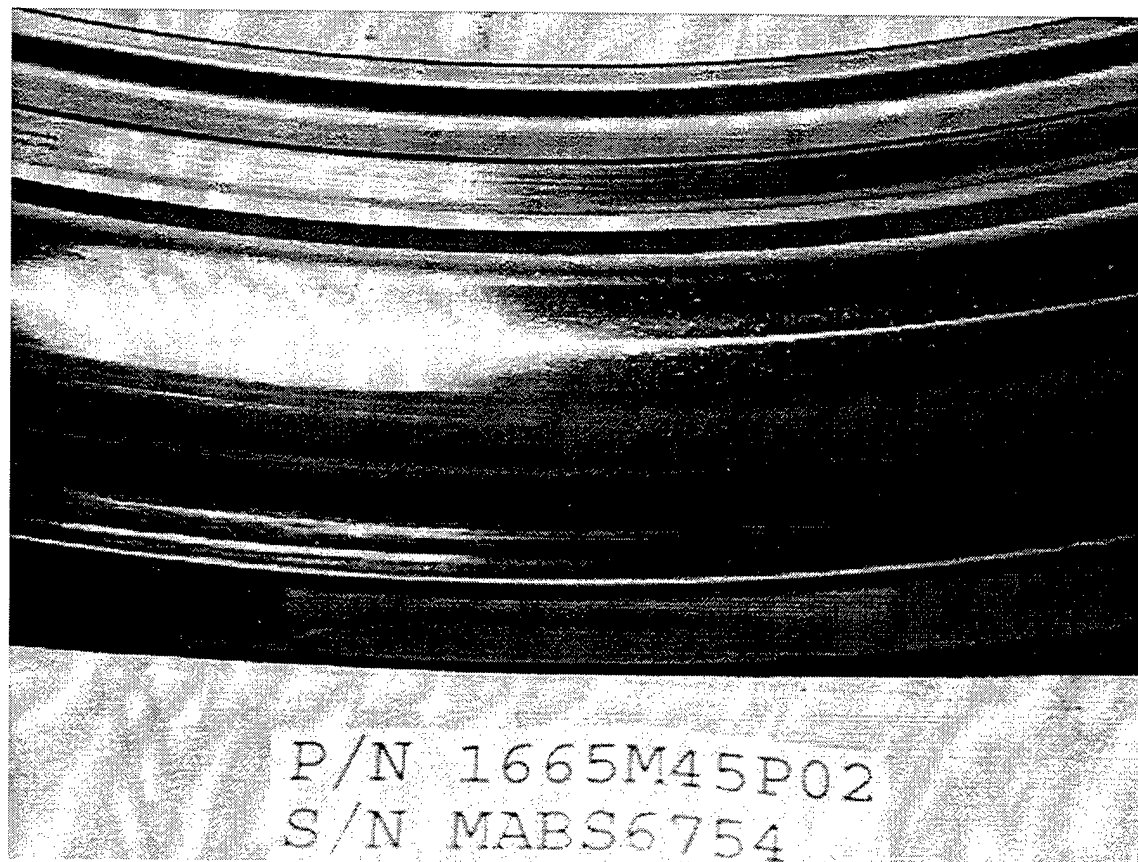
**Figure 118. Photo of Contamination Tested TDC Bearing.**  
*TDC coated bearings demonstrated superior contamination resistance.*

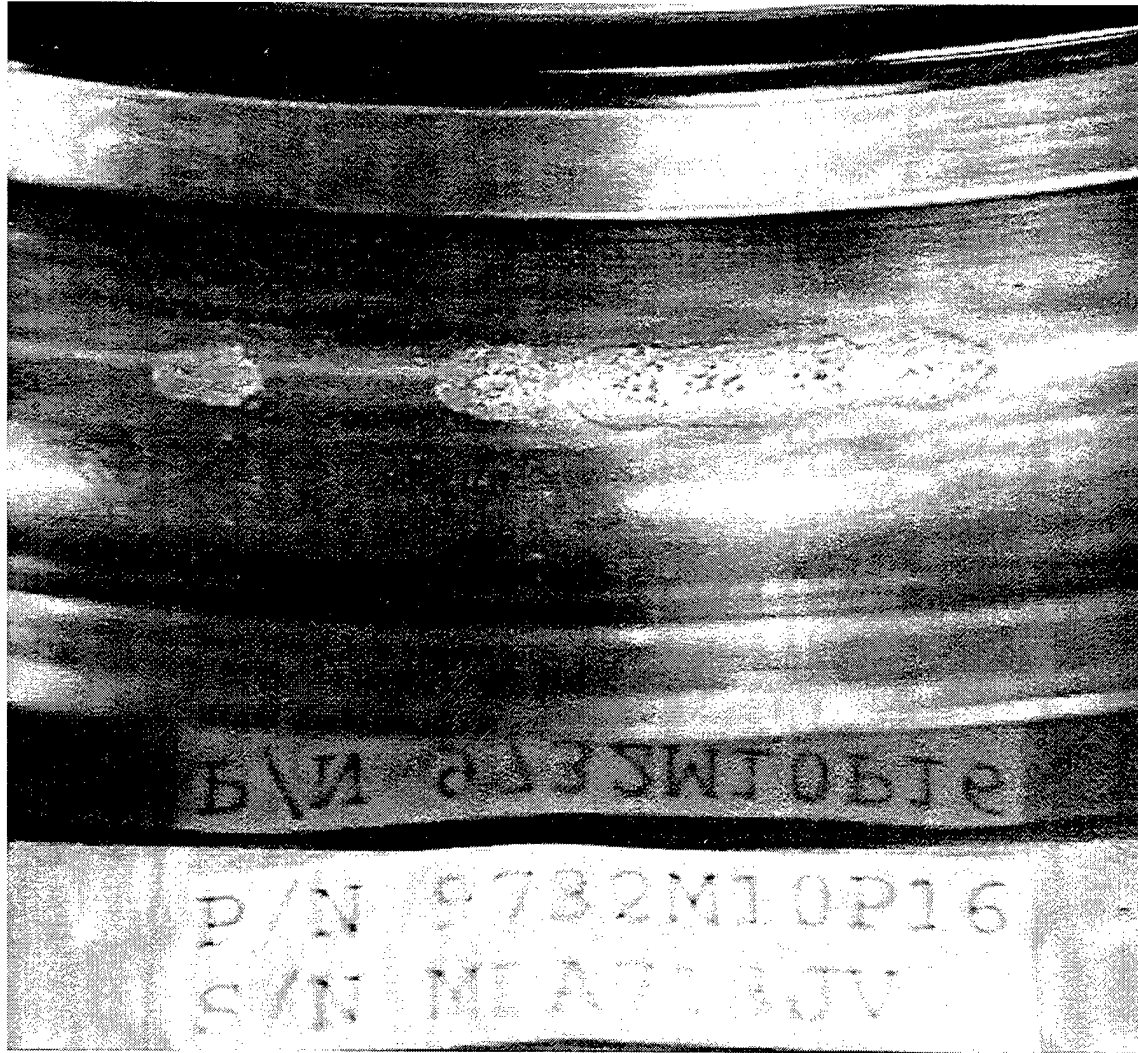
Figure 120. Photo of Outer Race Spalling on Bare, Contamination Tested Bearing.  
*Bare bearings repeatedly demonstrated less resistance to contamination.*

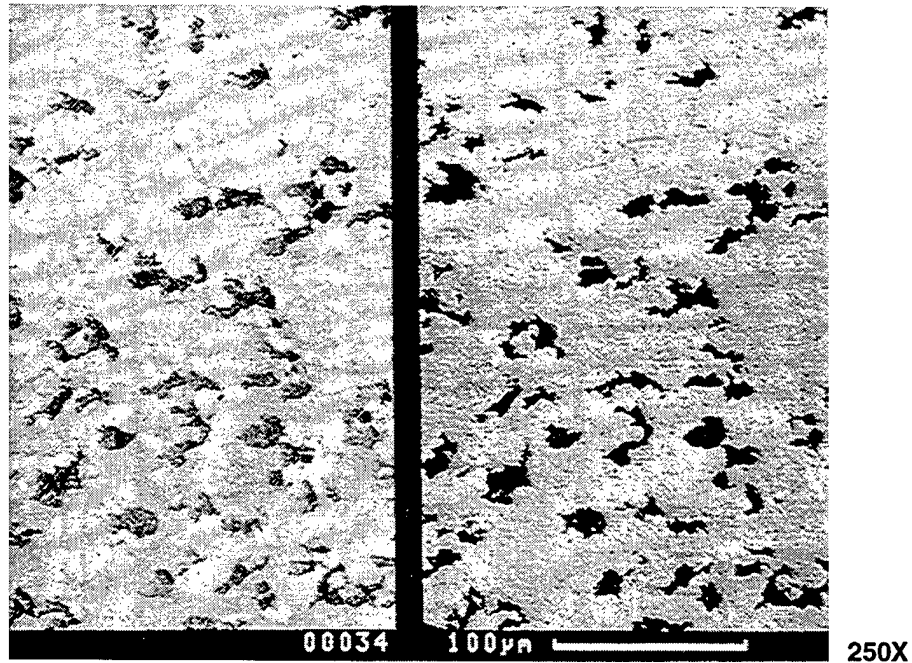
**Figure 122. Microphotograph of Skid Damaged Inner Race TDC on Bearing S/N MDACE700.**  
*Light colored areas in the left image highlight the smeared M50 from the balls. Dark areas in the right image indicate partial TDC pull out.*

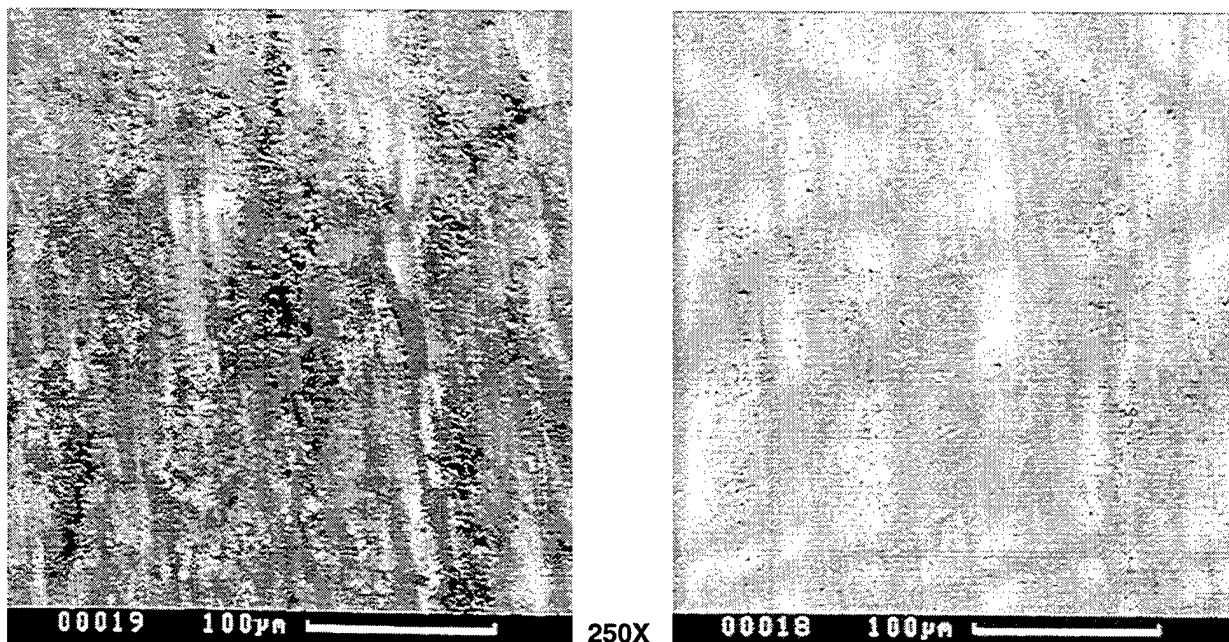
**Figure 123. SEM Photograph of Skid Damaged Ball on Bearing S/N MDACE700.**  
*Carbides (lighter areas) in the right photo appear to be broken up and smaller than undamaged areas of the ball.*

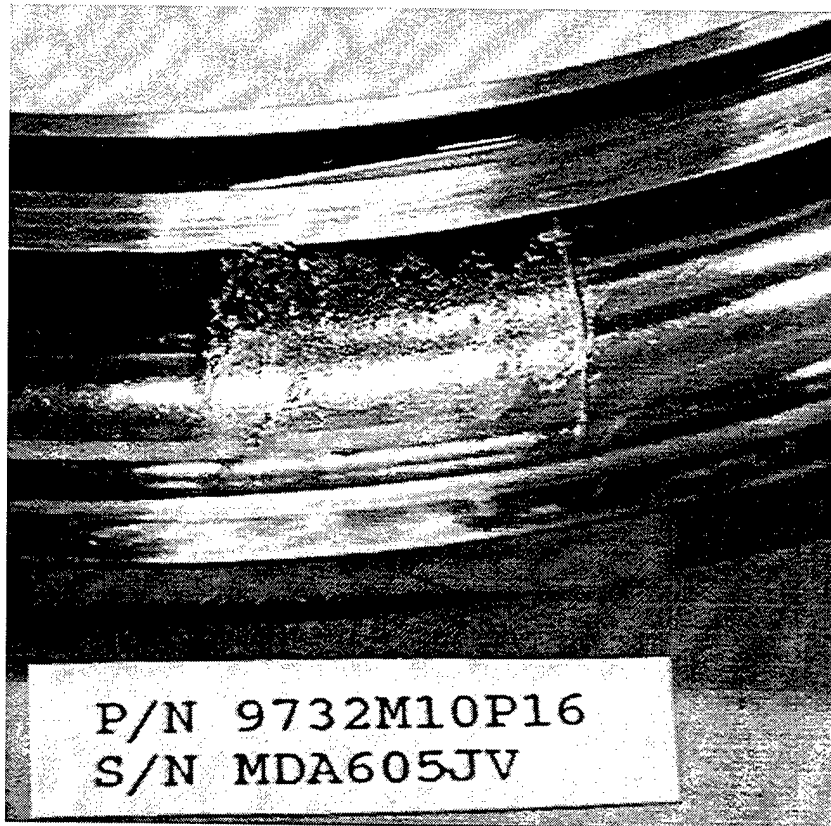
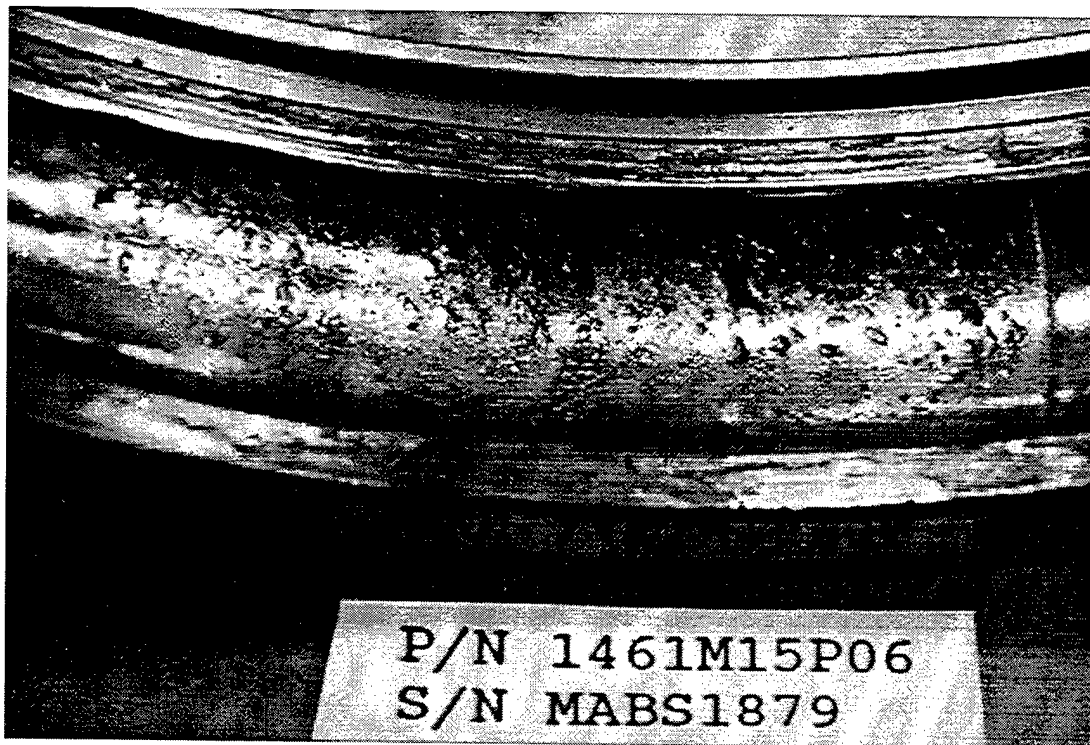
Figure 125. Photos of Plain Bearing Race Damage Evident after Induced Defect Test.

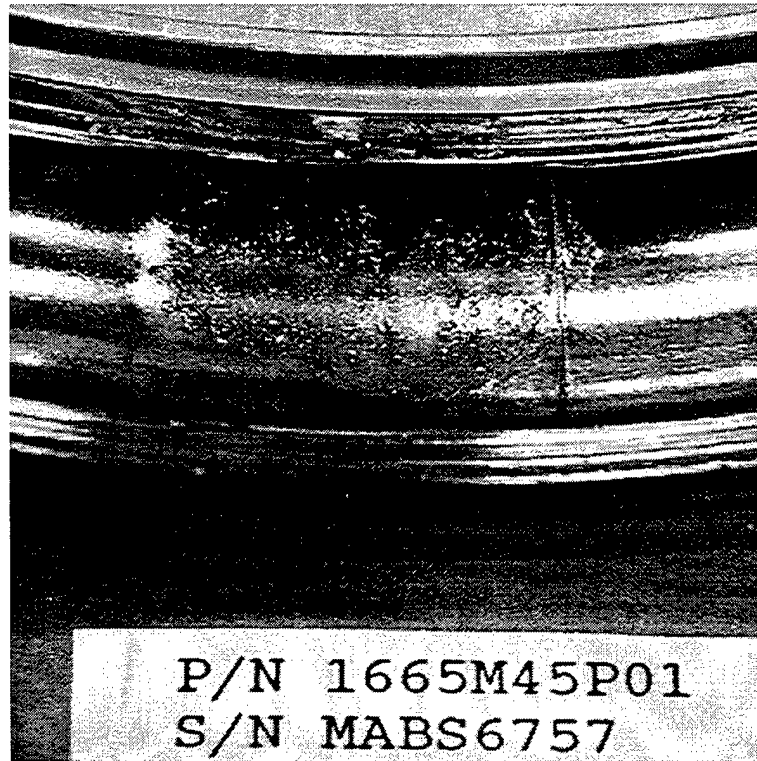
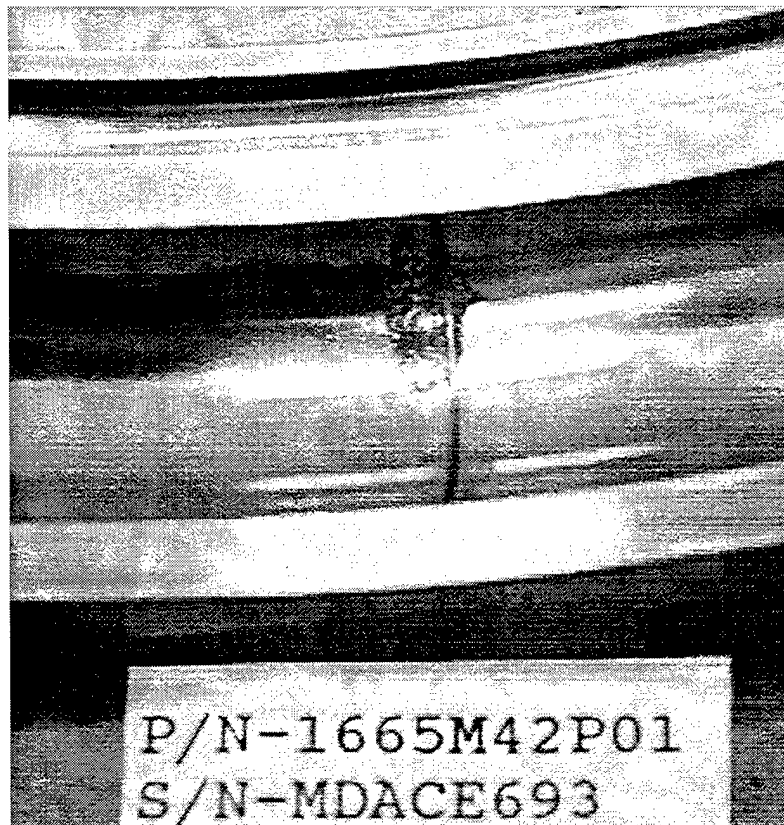
**Figure 126. Photos of TDC Coated Bearing Race Damage Evident after Induced Defect Test.**  
*Note reduced level of damage compared to plain bearings Figure 125.*

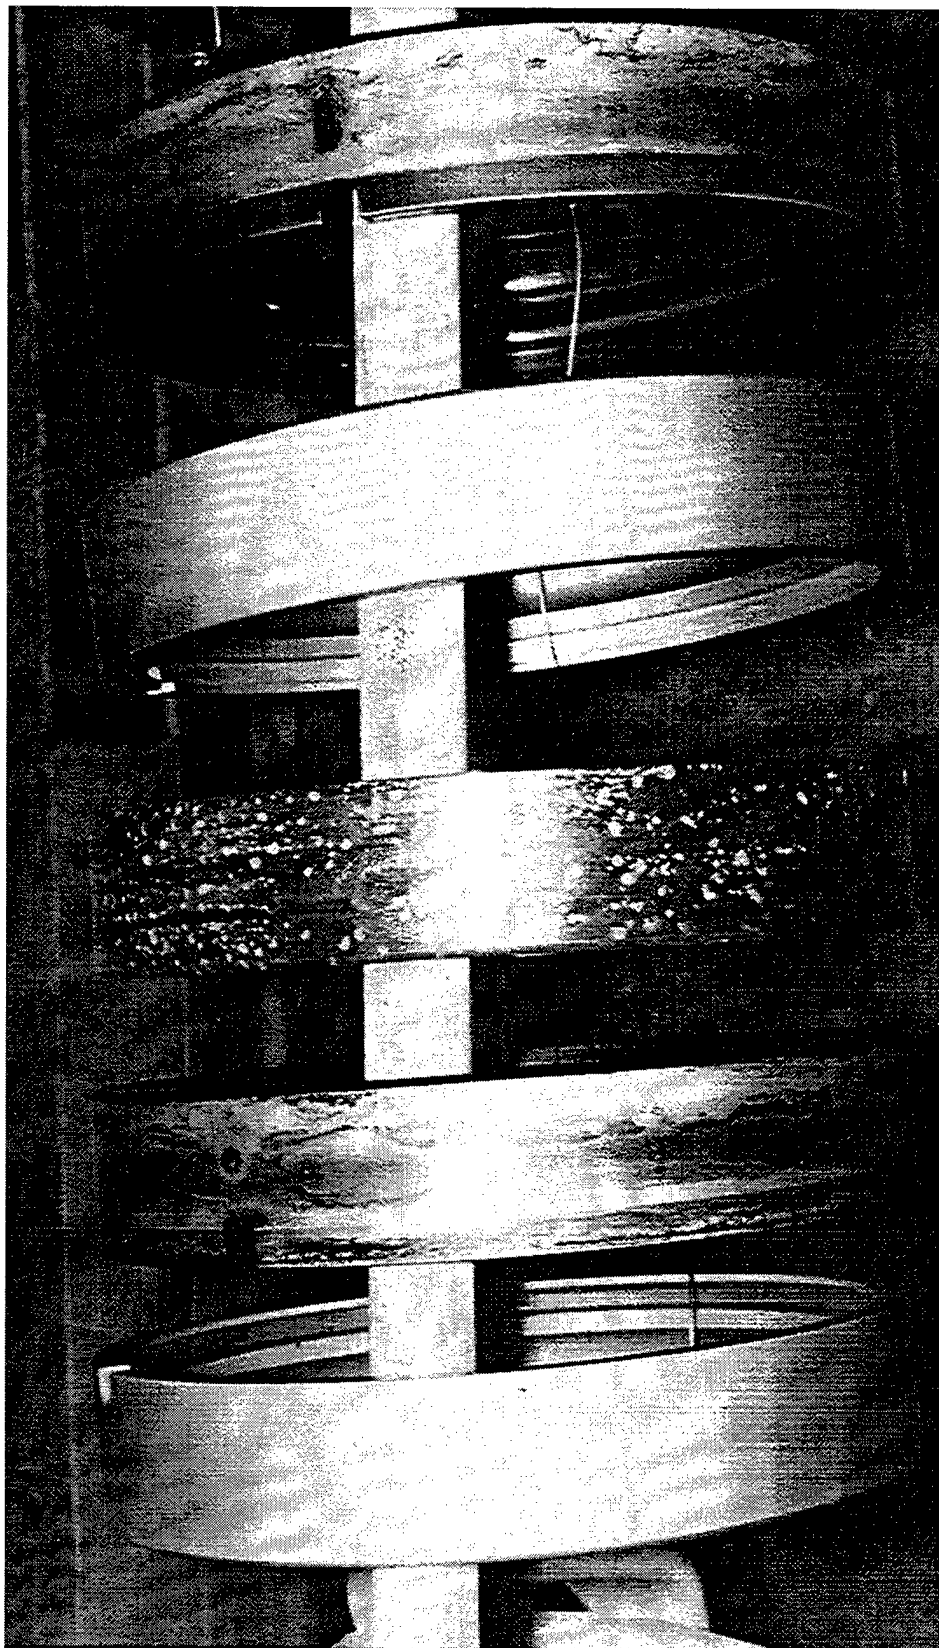
**Figure 127. Photos of Corrosion Resistance Test Bearings.**  
*TDC coating significantly improved corrosion resistance.*

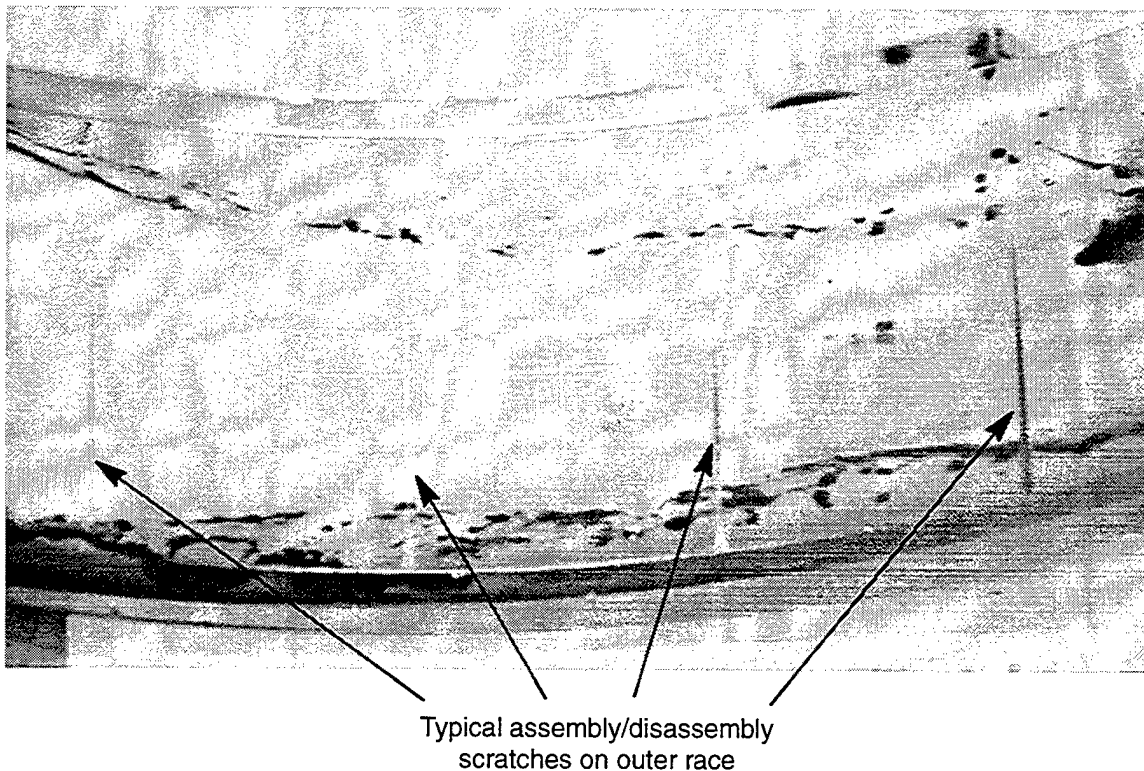
**Figure 129. Photo of F110 No. 4R Bearing Outer Race TDC Coating Assembly Damage.**

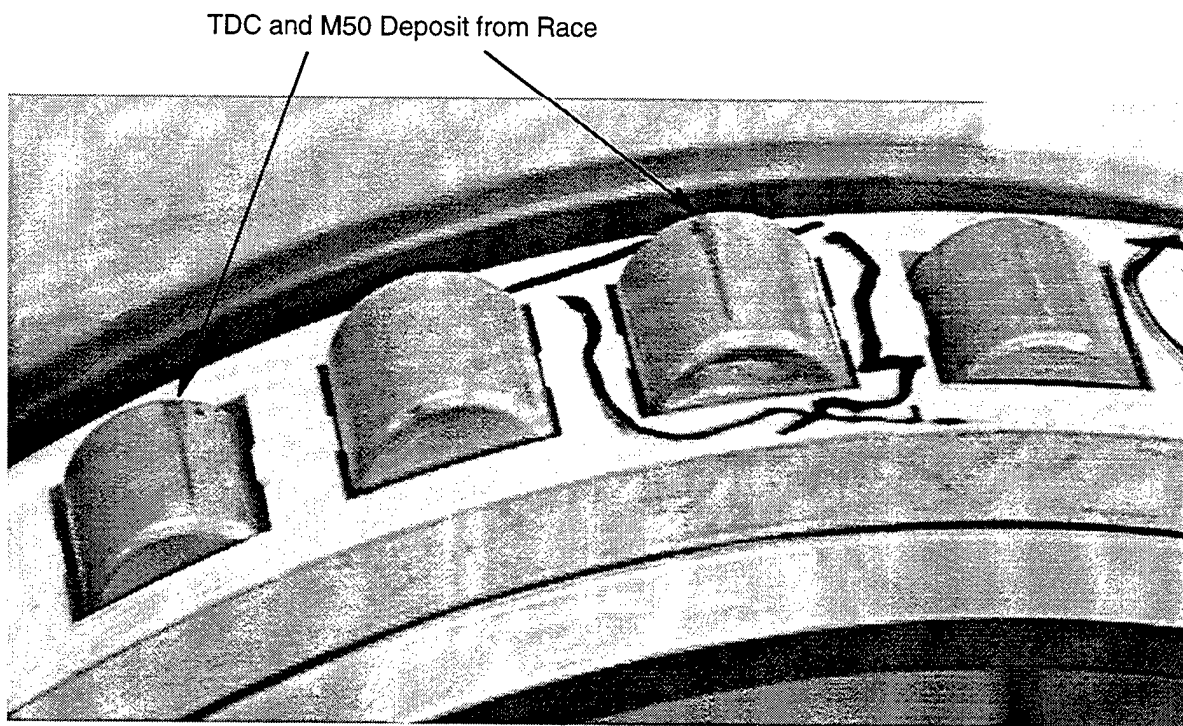
**Figure 130. Photo of Assembly Damage to Roller TDC Coating.**

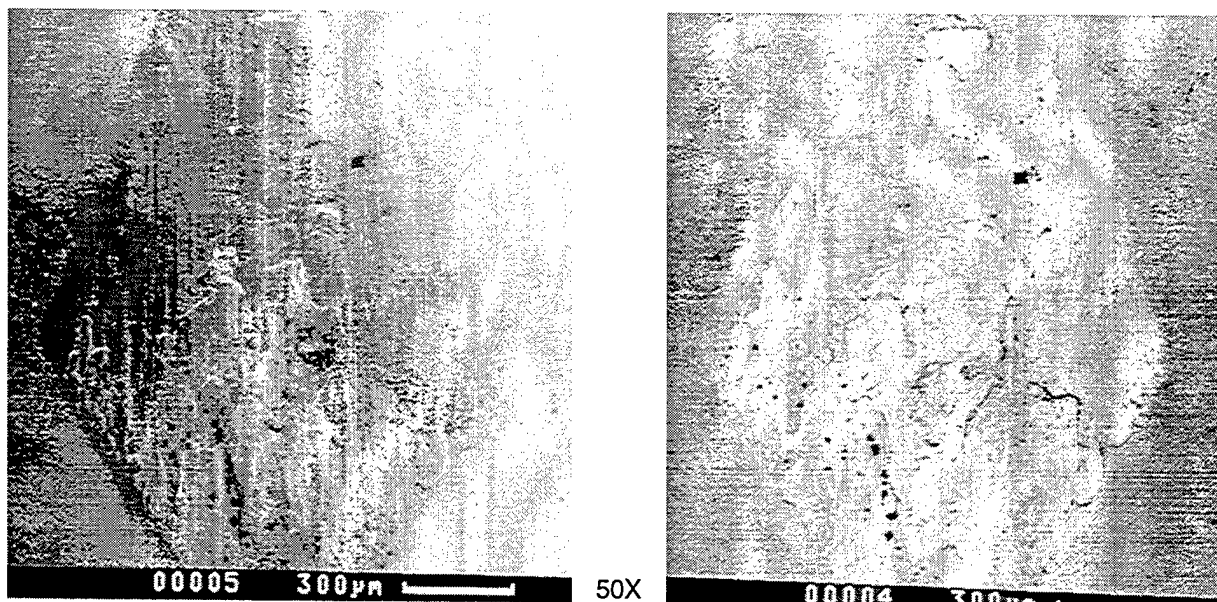
**Figure 131. SEM Secondary and Backscatter Photos of Roller Assembly Damage.**  
*Smearred areas indicate M50 material deposited from the race.*
